THE EFFECT OF FLUID FLOW RATE ON THE CORROSION RATE OF THE PIPE OF SEAWATER SYSTEM

Corrosion is a process of decreasing the quality of a material because it reacts with the environment. The corrosion process takes place spontaneously and is a natural event that cannot be avoided. This research was carried out to determine the relationship between the fluid flow rate of seawater flowing in the channels of API 5L grade B standard galvanized pipe and seamless pipe specimens on the corrosion rate using flow modeling for 4 months. The research variations used were variations in flow rate, namely 50%, 75%, and 100%. Corroded pipe specimens were cleaned, weighed, and photomicrography. From this research, it was found that the higher the flow rate, the higher the corrosion rate that occurs, and the corrosion that occurs is abrasion corrosion and pitting corrosion.

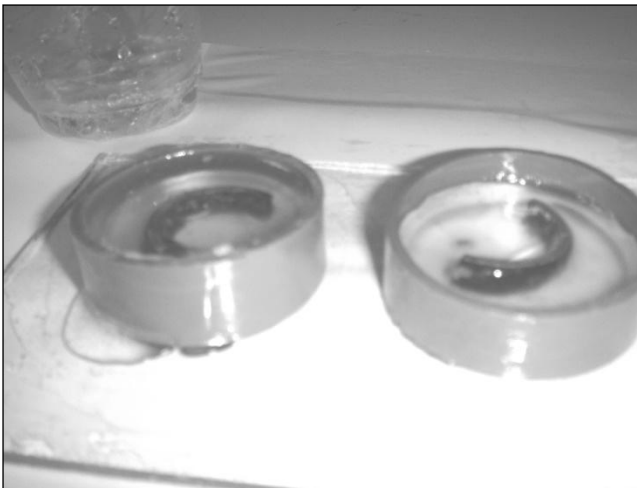
Figure 4. Fiber printing process

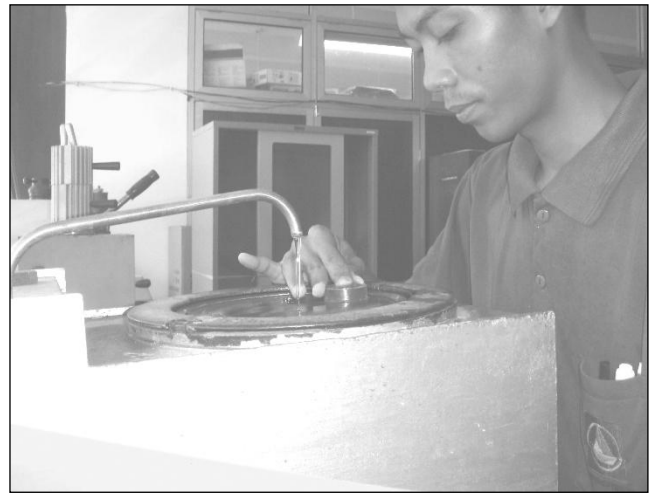
Figure 5. Material polishing

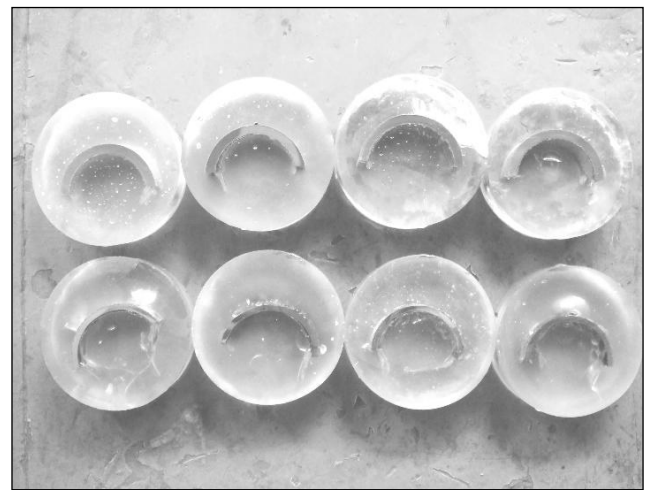
Figure 6. Polishing results

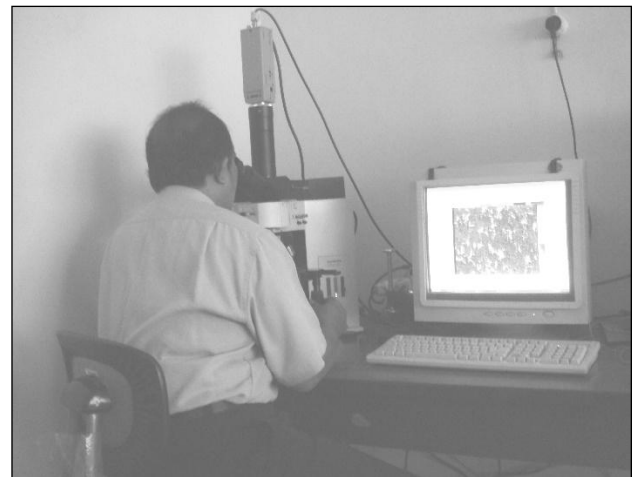
Figure 7. Micrography process

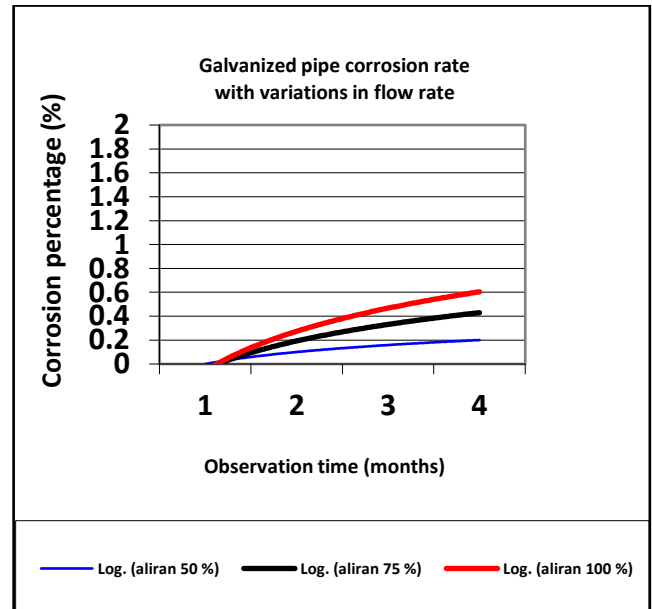
Figure 8. Comparison of corrosion rate with variations in fluid flow rate in the galvanized pipes

Figure 8 shows a comparison between the corrosion rates that occur between each flow rate, where the corrosion rate of galvanized pipe at a flow rate of 100% occupies the highest position, followed by a flow rate of 75% and a flow rate of 50%, or in other words the more the higher the flow rate through the galvanized pipe, the greater the rate of corrosion that occurs in the pipe.

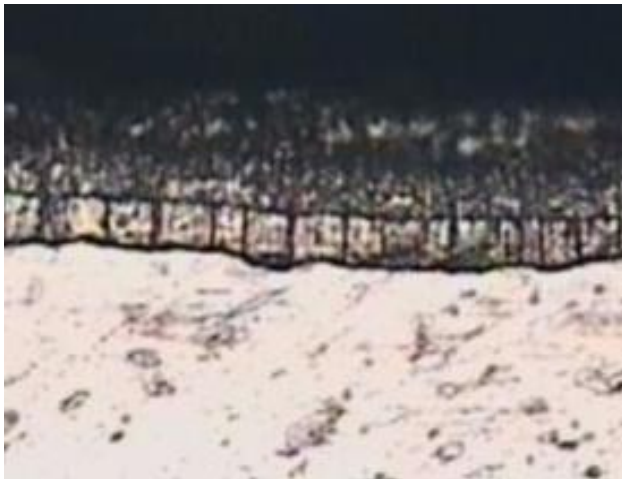
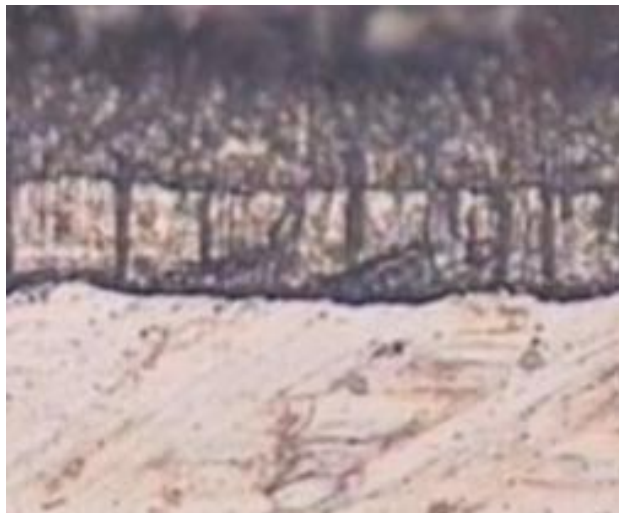
Figure 12. Photo of the microstructure of the galvanized pipe specimen, with a fluid flow rate of 0%, (a) 50x magnification, (b) 200x magnification

From metallographic observations, there is no visible intergranular corrosion or corrosion at the grain boundaries of the microstructure. Meanwhile, on visual observation, some specimens showed pitting and abrasion marks on the pipe surface, both galvanized and non-galvanized pipes. From this observation, we can conclude that the corrosion that occurs is abrasion and pitting corrosion.

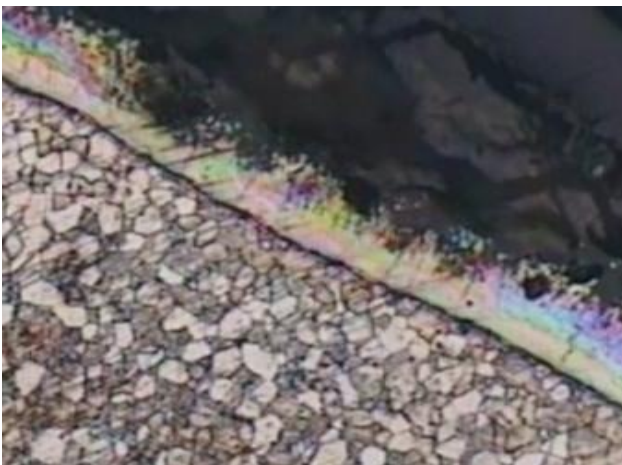
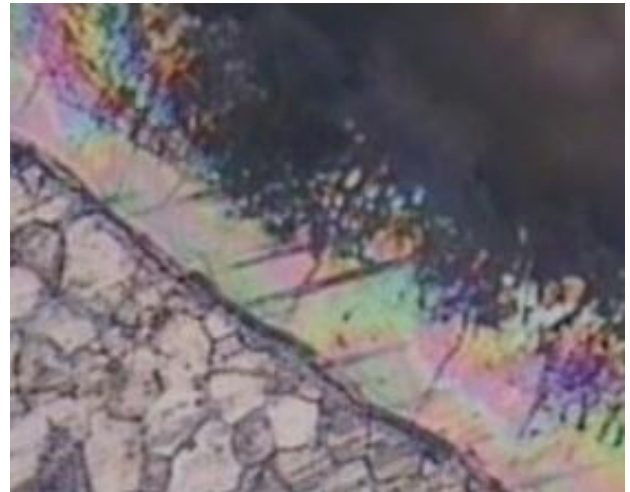
Figure 13. Photo of the microstructure of the galvanized pipe specimen, with a fluid flow rate of 50%, (a) 50x magnification, (b) 200x magnification

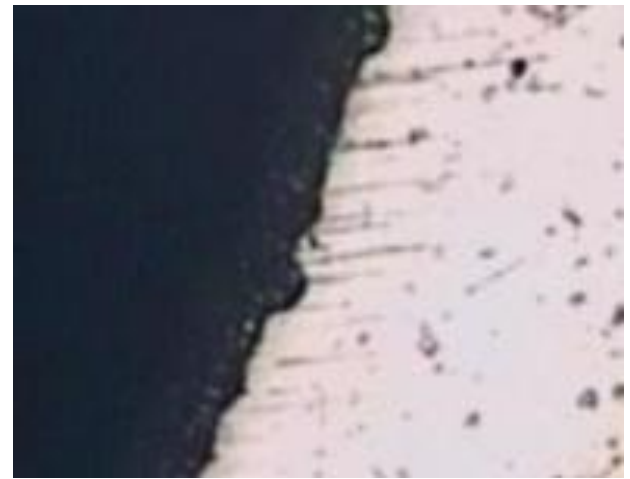
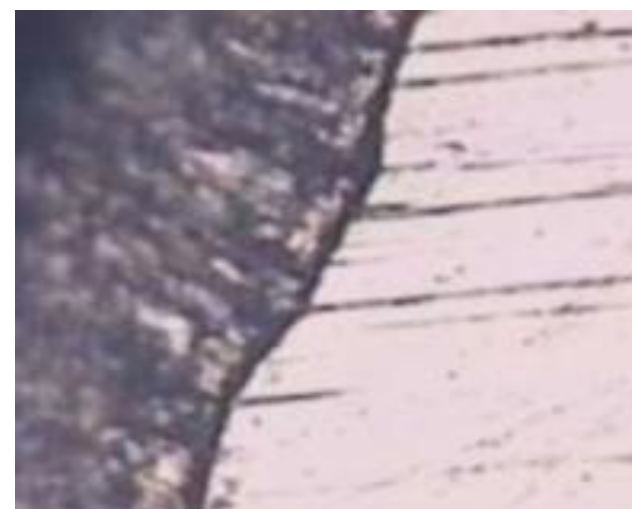
Figure 14. Photo of the microstructure of the galvanized pipe specimen, with a fluid flow rate of 75%, (a) 50x magnification, (b) 200x magnification

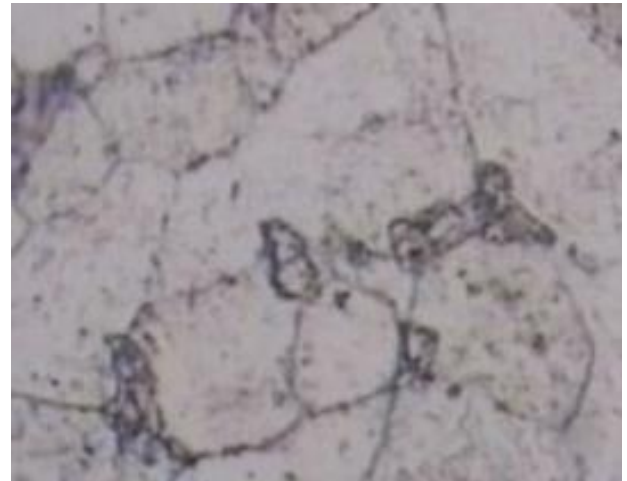
Figure 16. Photo of the microstructure of the non-galvanized pipe specimen before the corrosion test, (a) 100x magnification, (b) 500x magnification

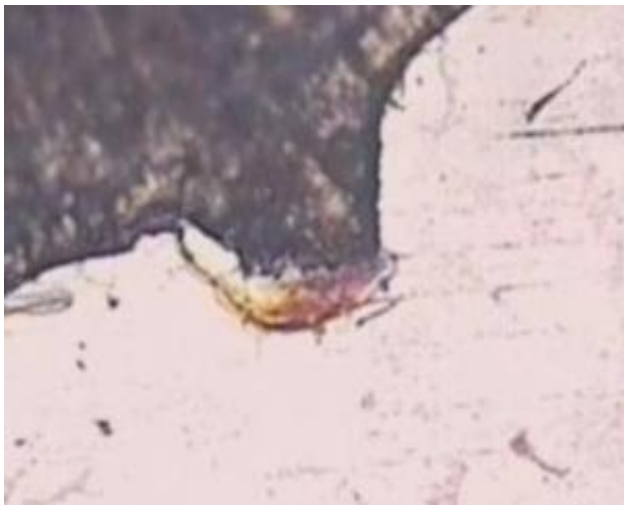
Figure 15. Photo of the microstructure of the galvanized pipe specimen, with a fluid flow rate of 100%, (a) 50x magnification, (b) 200x magnification

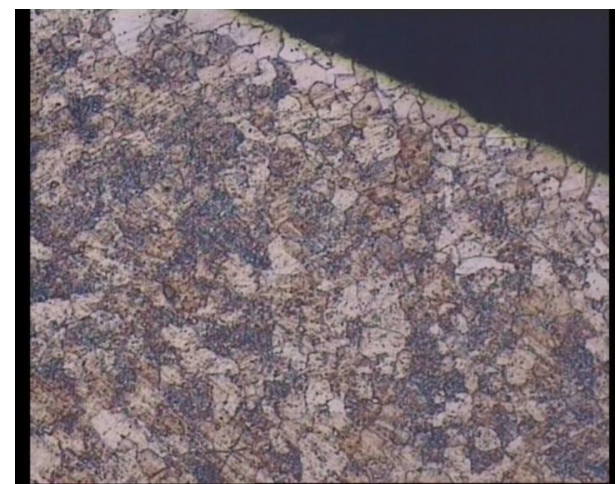
Figure 17. Photo of the microstructure of the non-galvanized pipe specimen, with a fluid flow rate of 0%, (a) 50x magnification, (b) 200x magnification

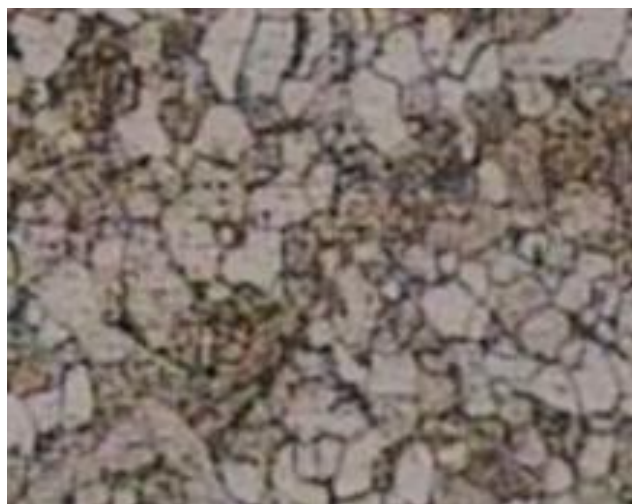
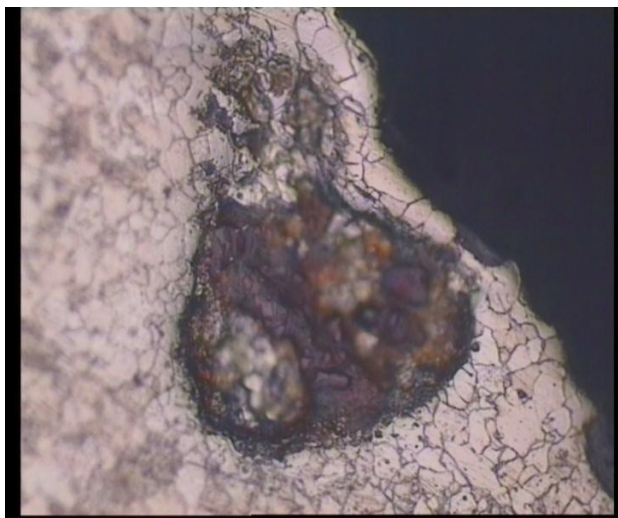
Figure 18. Photo of the microstructure of the non-galvanized pipe specimen, with a fluid flow rate of 50%, (a) 50x magnification, (b) 200x magnification

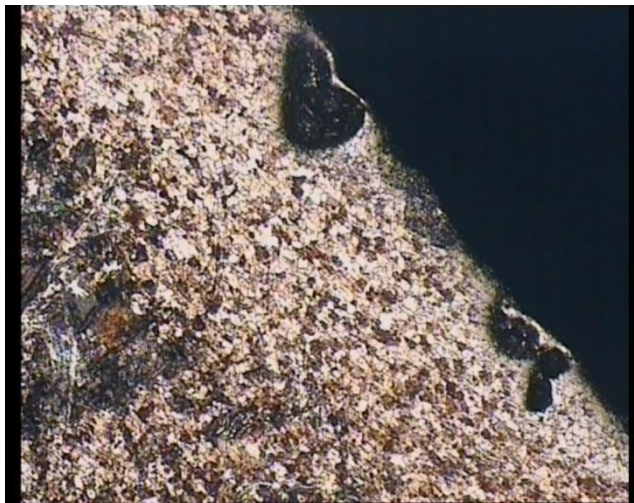
Figure 19. Photo of the microstructure of the non-galvanized pipe specimen, with a fluid flow rate of 75%, (a) 50x magnification, (b) 200x magnification

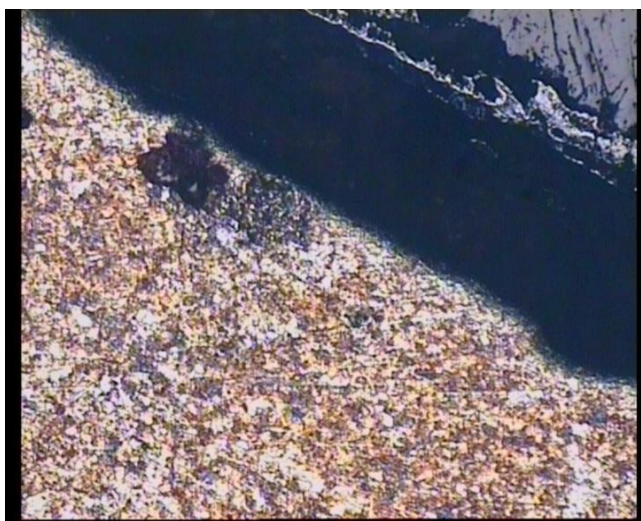
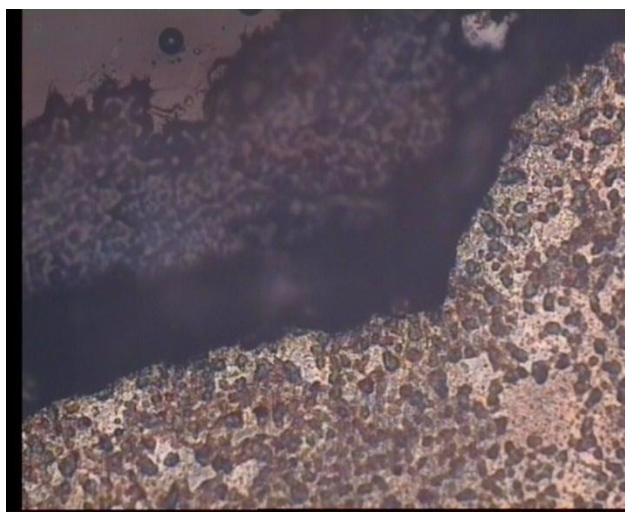
Figure 20. Photo of the microstructure of the non-galvanized pipe specimen, with a fluid flow rate of
